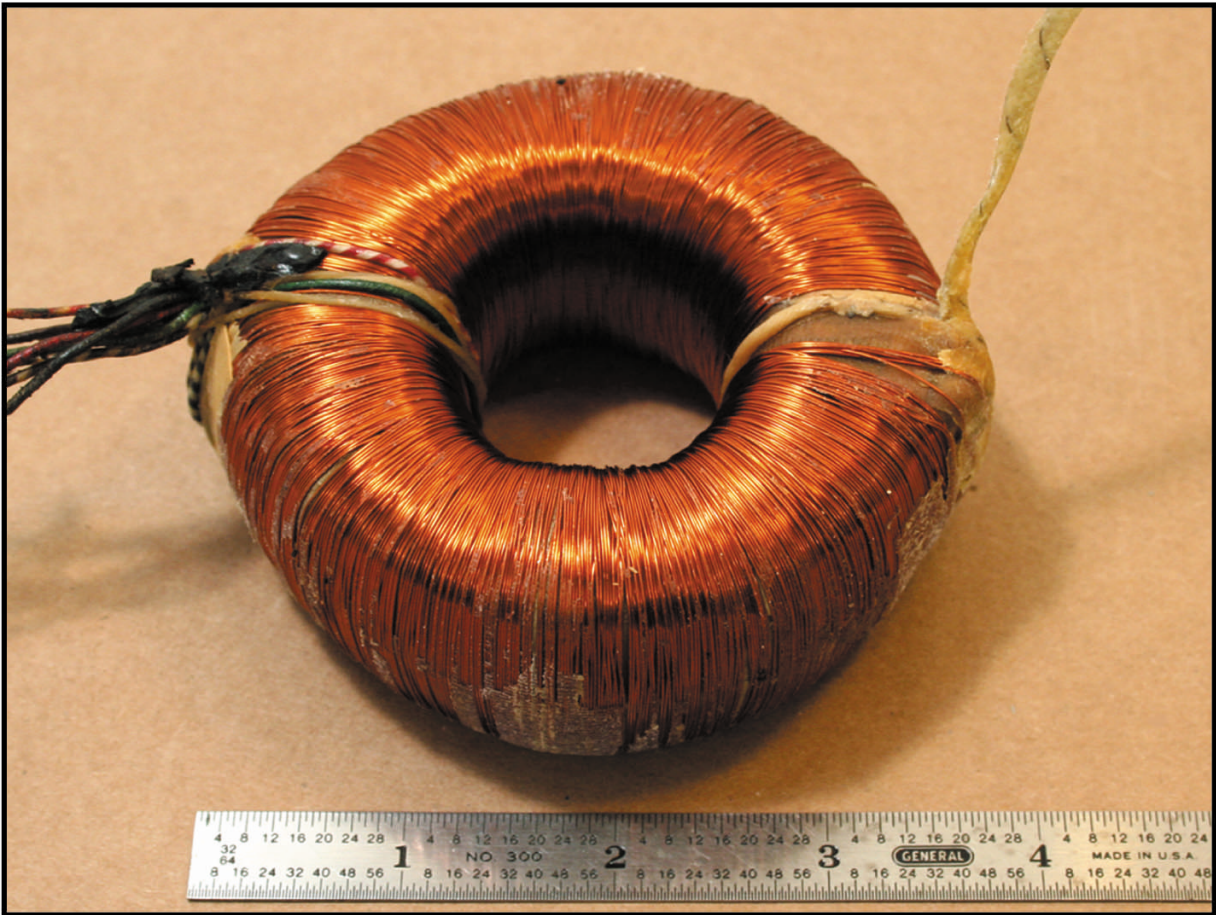
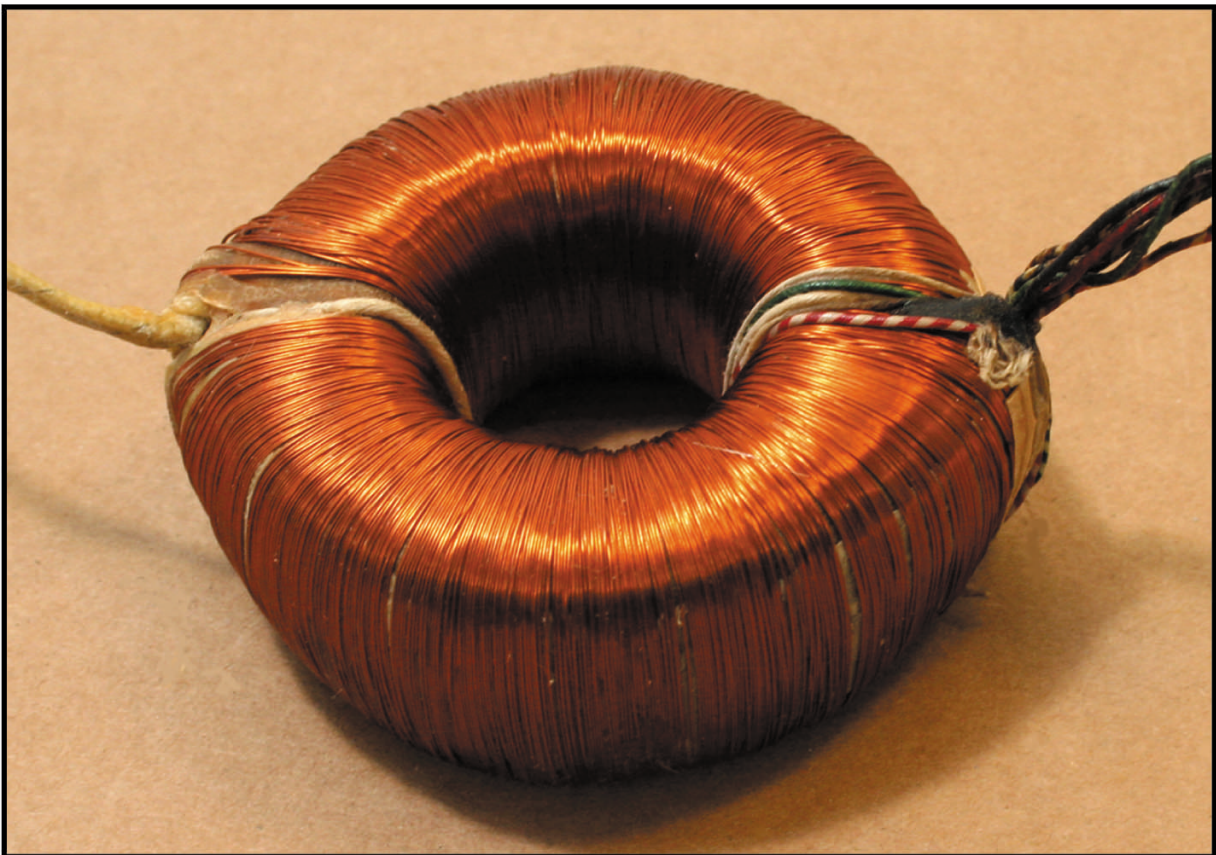
**Fig. 10** Here are a couple of photos of the coil directly after the wrapping was removed. The outer winding has no other wrapping or shield.
